Article Number - 00026-2011

Article applies to - AIT250 and AIT1000

ISSUE: Recovery from a failed AIT250 or AIT1000 Software Upgrade

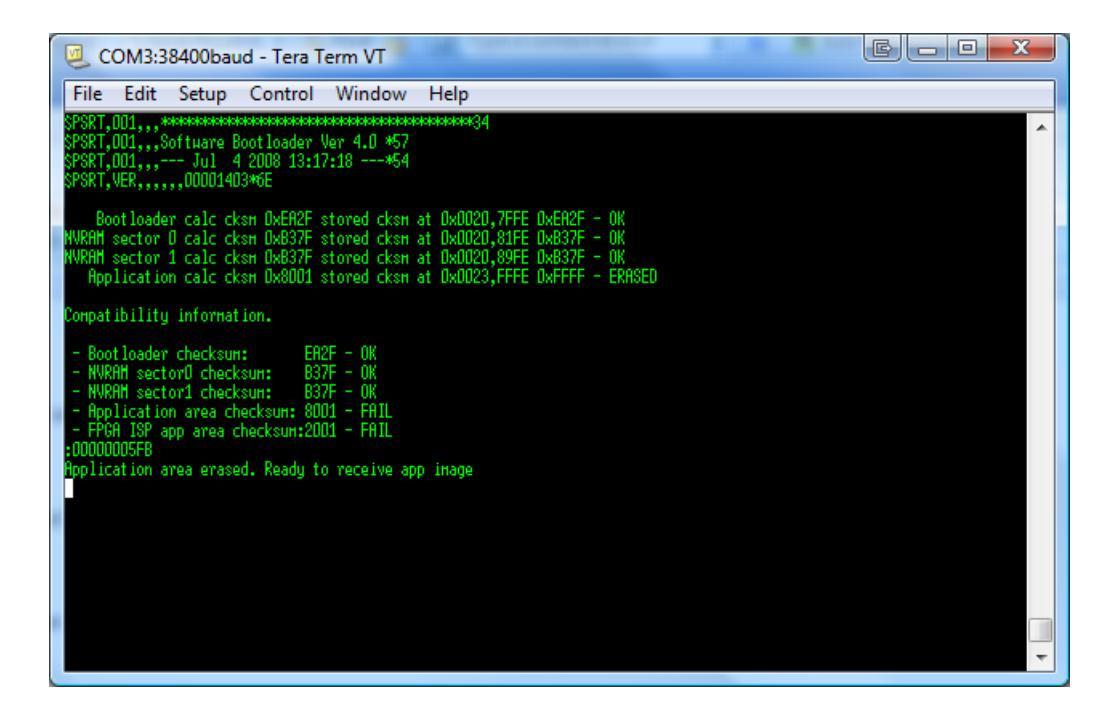
6) The terminal will now indicate that the application area has been erased and is ready for update, see screen shot on next page;

- 7) Now use the 'File -> Send File' command in TeraTerm and send the "sirius3_10_11_14_0.hex" file to the unit. Do not interrupt power or serial connection to the transceiver whilst the update is in progress.
- 8) Once the upload has completed the terminal will show the checksum and other information similar to that shown below:
